Operation and Maintenance Report
January 2017 to December 2017

McCormick and Baxter Superfund Site

Portland, Oregon
ECSI Site No. 74

March 29, 2018
15670-10/Task 4

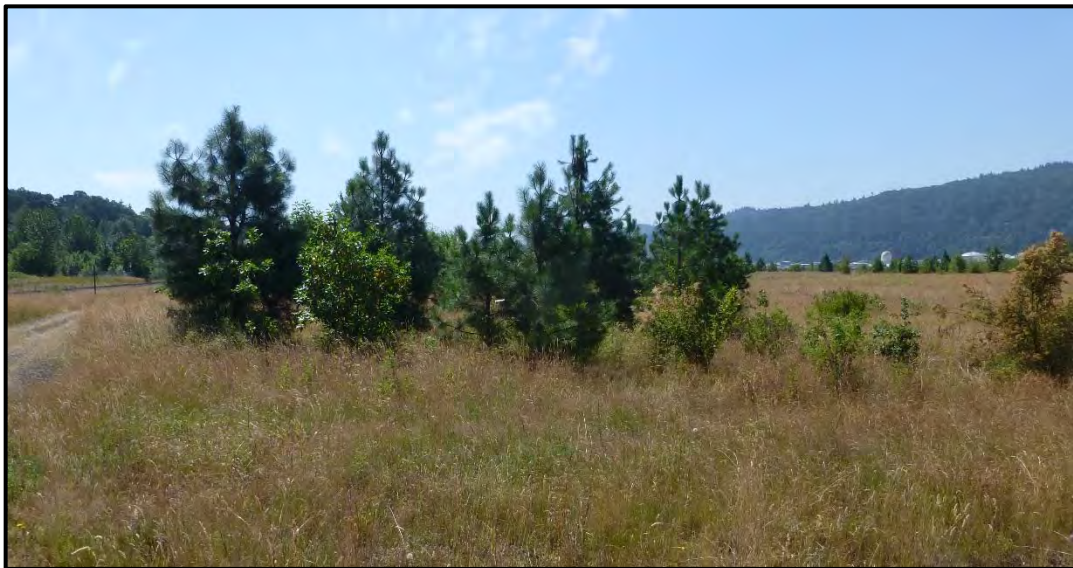
Earthen Cap Component. Tree and shrub plantings on the earthen cap were healthy and growing well (Photographs 2, 3, and 5, Appendix C). Ponderosa pine, Oregon grape, elderberry, lupine, and serviceberry continue to be performing the best. Nootka rose dominated the northwest portion of the earthen cap. Trees and shrubs ranged in height from approximately 6 to 15 plus feet. Herbaceous species provided full coverage of the ground. During our June 2017 site visit, gumweed, mullein, and goldenrod and various grasses were frequently observed throughout the earthen cap. No indications of significant stress were observed and oak tress appear to have recovered following recent dry summers. Localized areas of moss were observed in the herbaceous layer. Scattered areas of noxious weeds continue to be observed, but recent herbicide applications have been effective at reducing the weed density.

Photograph 2 - Tree and shrub plantings on the earthen cap. Taken looking southeast from Photograph Location 2. (June 2017)

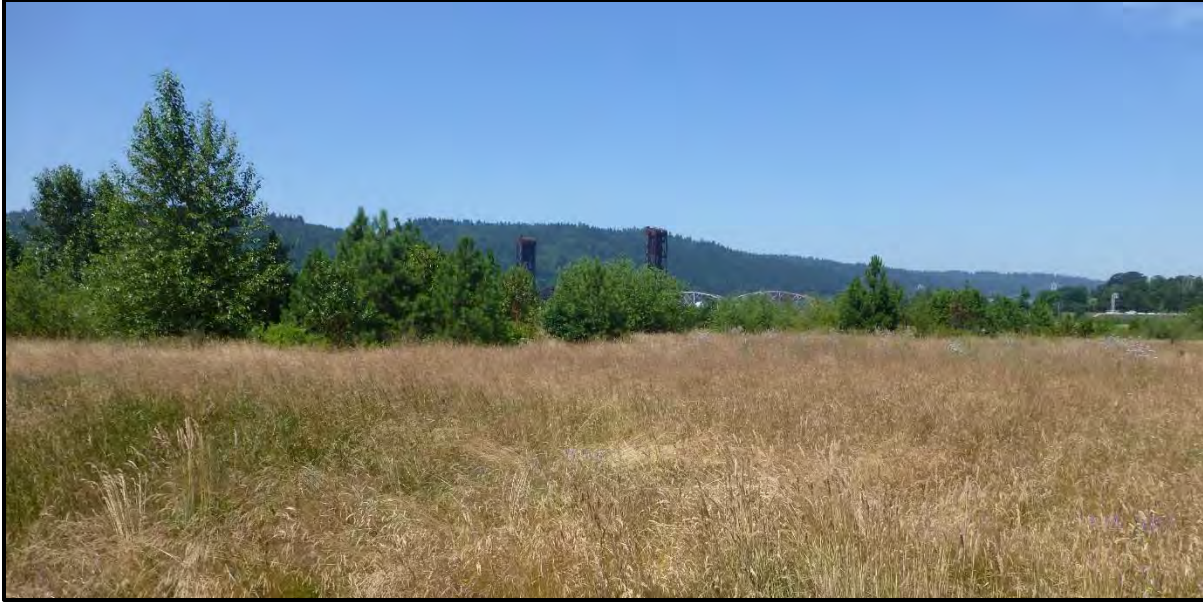
Photograph 3 – Eastern edge of the earthen cap looking toward the drainage swale. Taken looking west from Photograph Location 3. (June 2017)

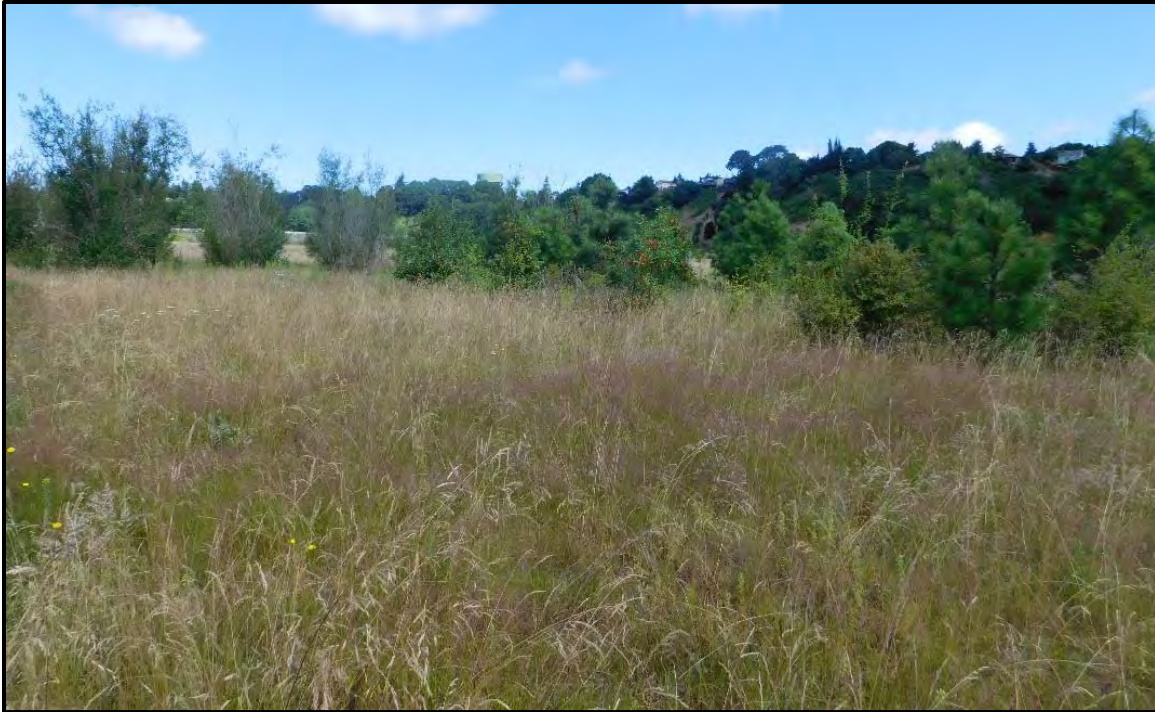
Photograph 5 – Tree plantings on the earthen cap. Taken looking north from Photograph Location 5. (June 2017).

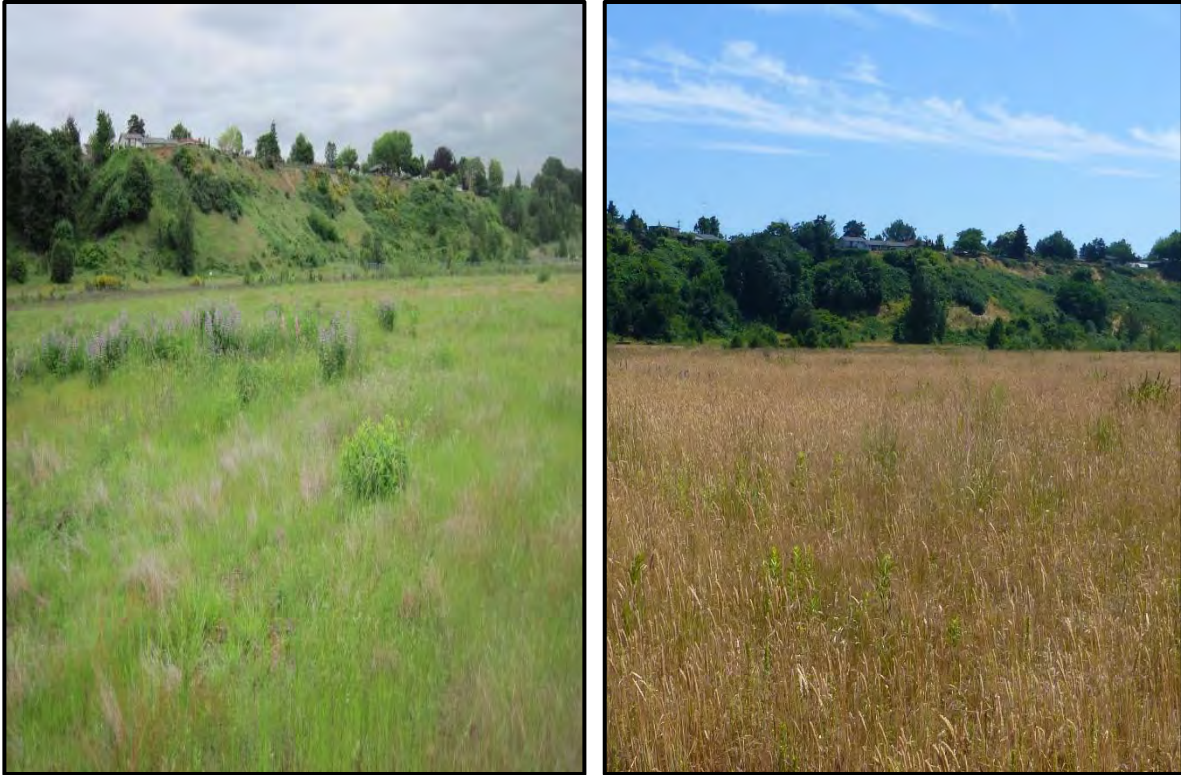
Impermeable Cap Component. The grassland species on the impermeable cap provided excellent coverage of the ground (Photograph 6, Appendix C). Gumweed was observed along the southwestern edge of the impermeable cap and provides increased diversity in this area. The remaining grasses and herbs were thriving. The spring 2017 herbicide treatment continued to shrink populations of scotch broom, knapweed, thistle, and skeleton weed that were observed on the cap. During the late spring, lupine appeared to be thriving, as an impressive spring bloom was observed.

Photograph 6 – Impermeable cap dominated by grasses and herbaceous vegetation. Baseline photograph on the left taken looking east from Photograph Location 6 (June – 2011). Current conditions from June 2017 shown on the right.

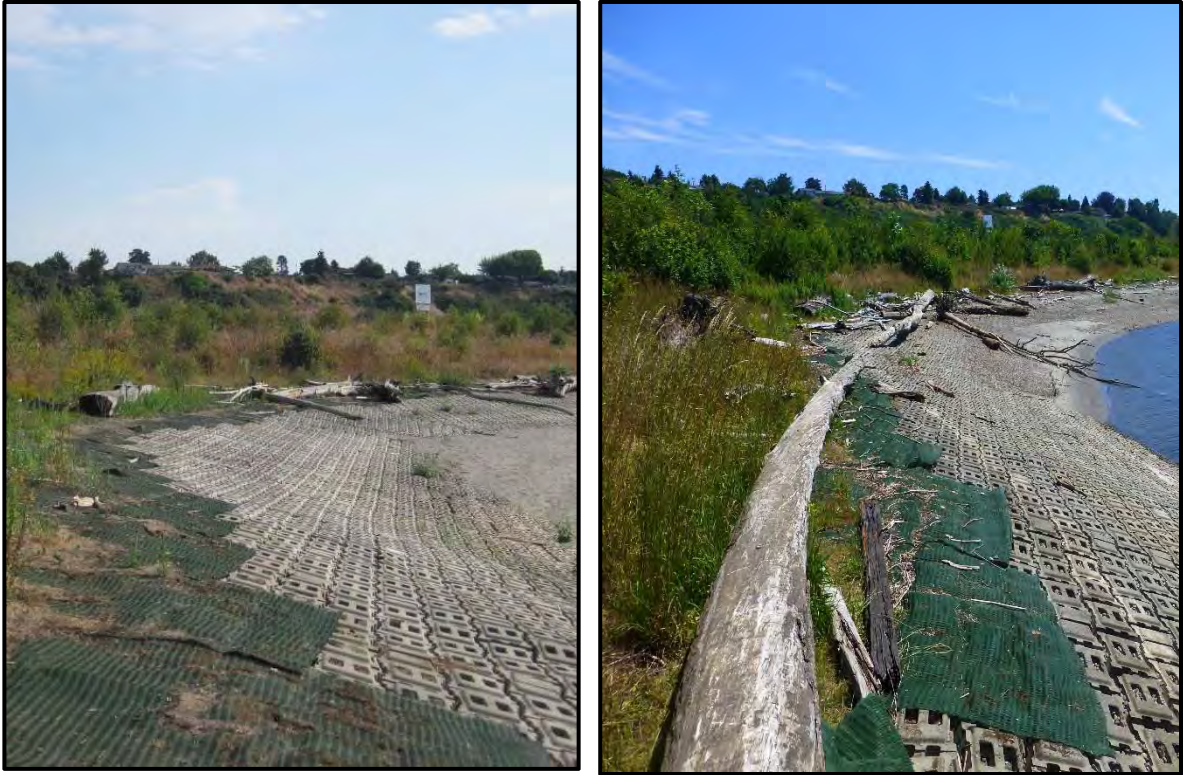
Photograph 7 – Vegetation growth and wood debris within the lower riparian component and along the shoreline. Taken looking southeast from Photograph Location 7 comparing baseline and current conditions. (Left - September 2011, Right – June 2017)

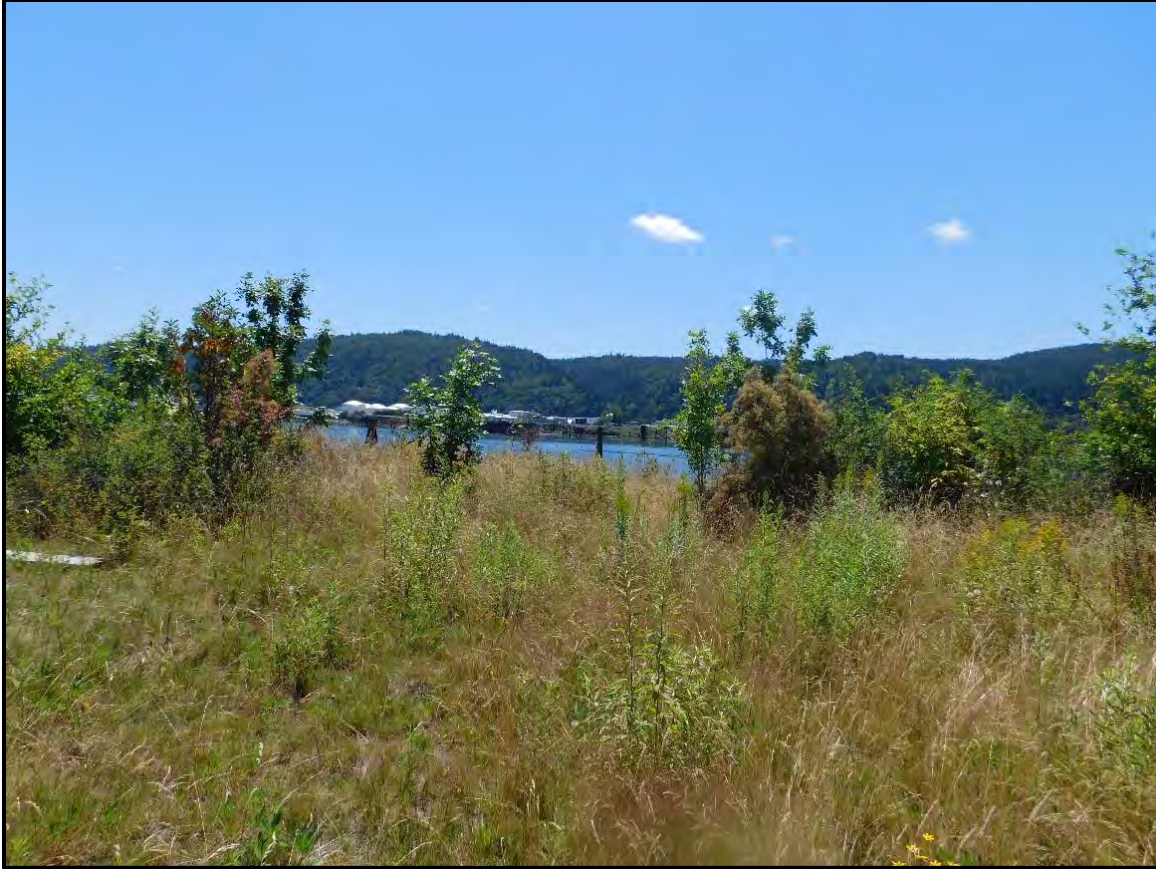
Photograph 8 – Upper riparian component with native trees and shrubs performing well. Taken looking southwest from Photograph Location 8. (June 2017)

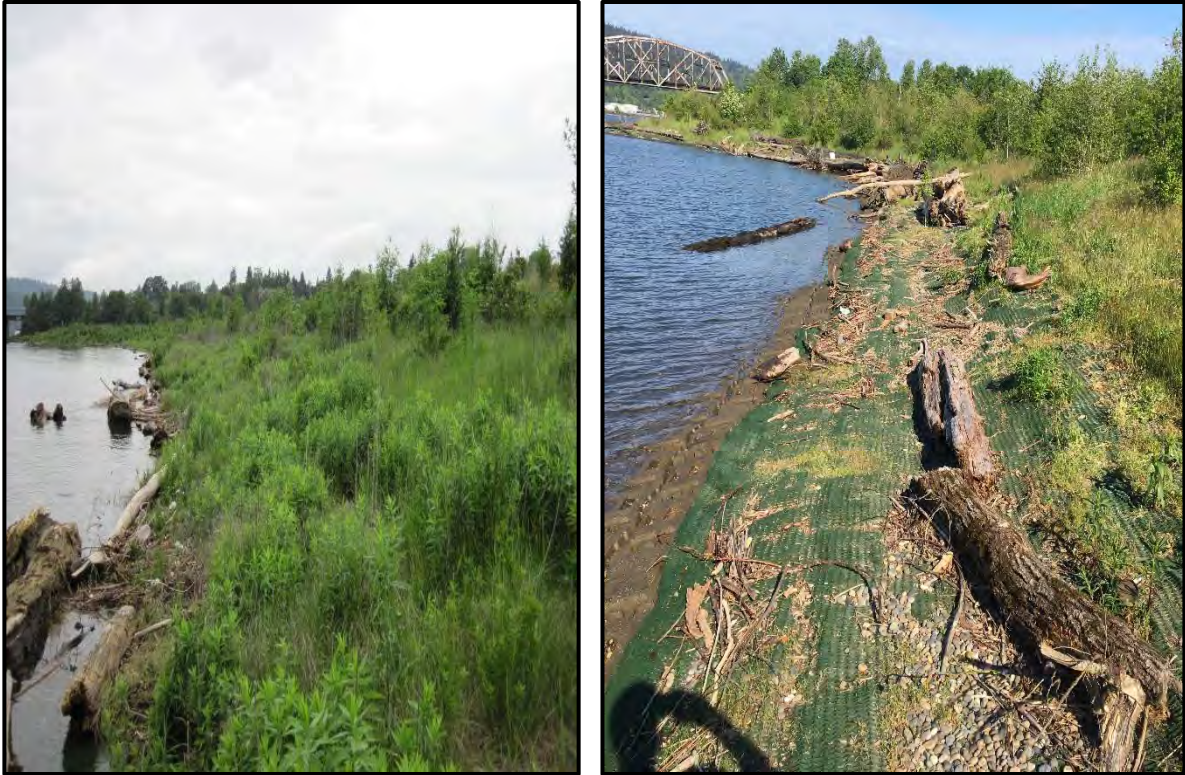
Photograph 9 – Lower riparian component with large wood debris along the edge. Taken looking northwest from Photograph Location 9 comparing baseline and current conditions. (Left - June 2011, Right – May 2017)

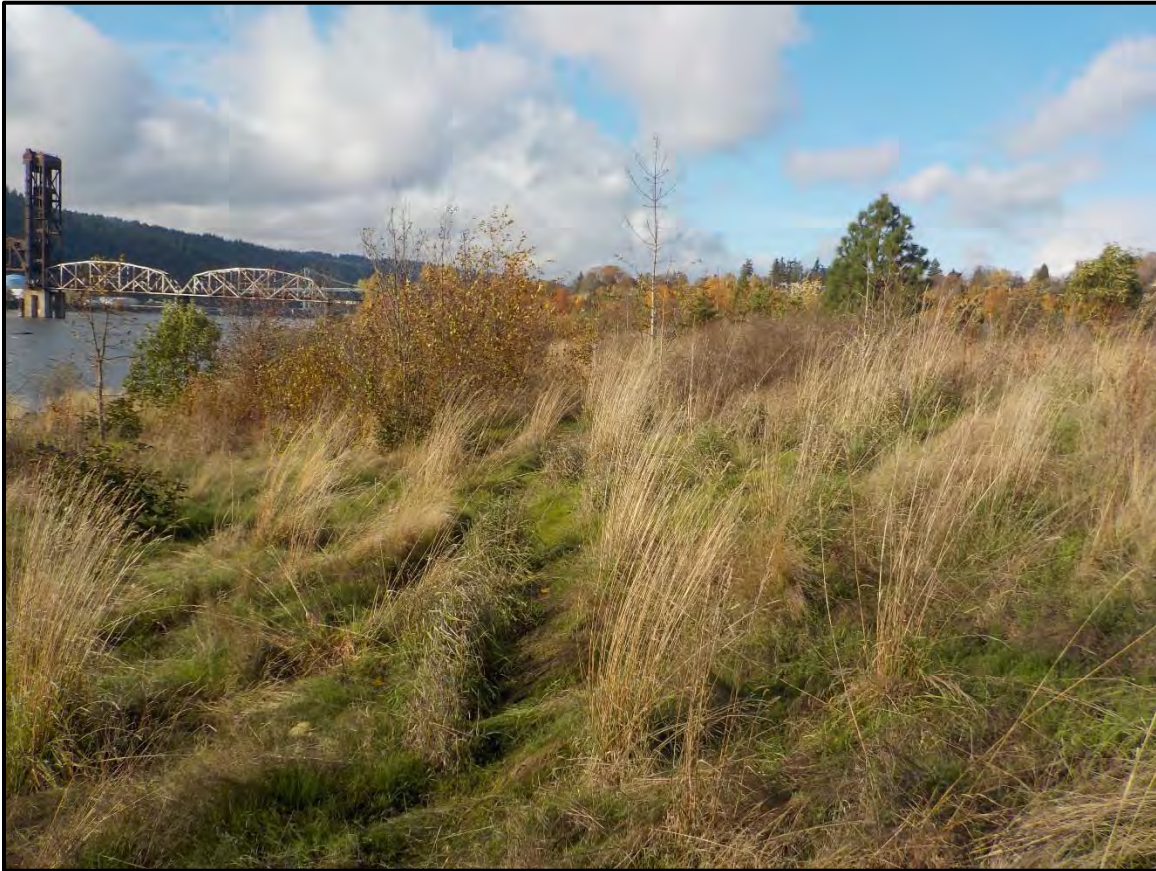
Photograph 10 – South end of the lower riparian area, looking northeast. Oregon ash, red osier-dogwood, and oak trees are faring relatively well within this area. (October 2017)
